# **First Five-Year Review Report**

## **Motor Wheel Disposal Site**

**Lansing, Ingham County, Michigan**

**July 2002**

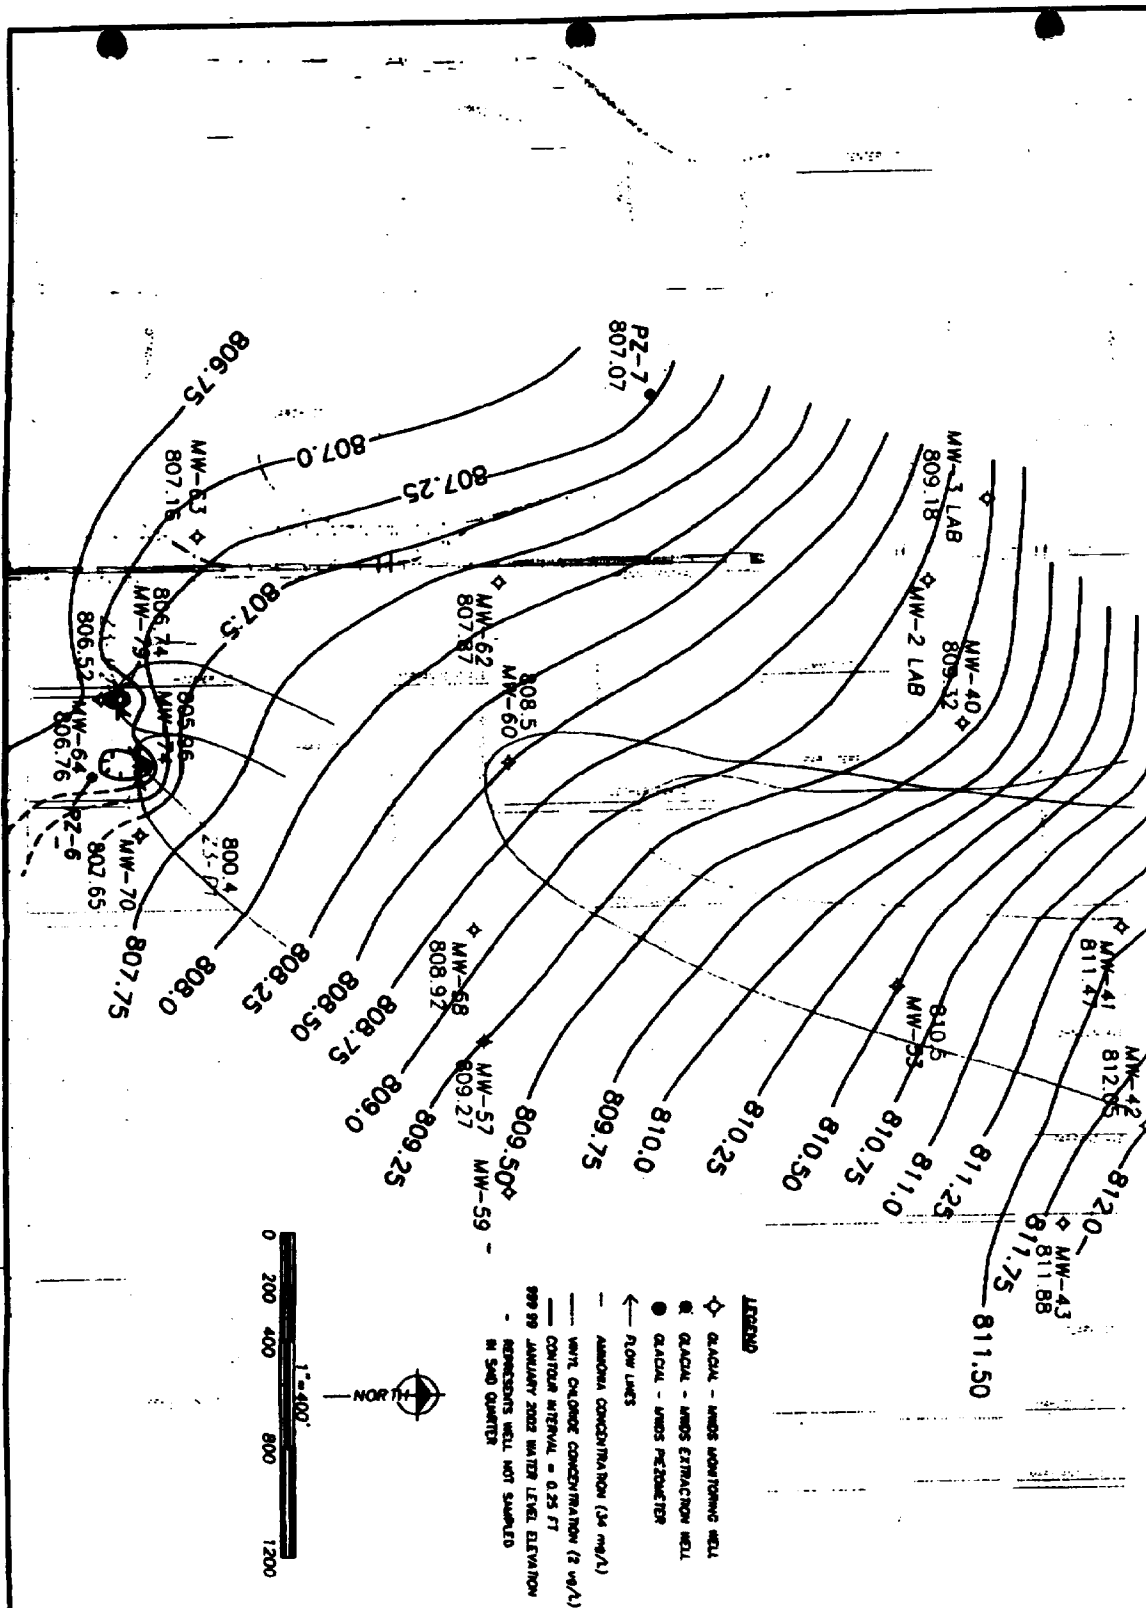
3C

ZONE 3  
CAPTURE ANALYSIS  
JANUARY 22-23, 2002

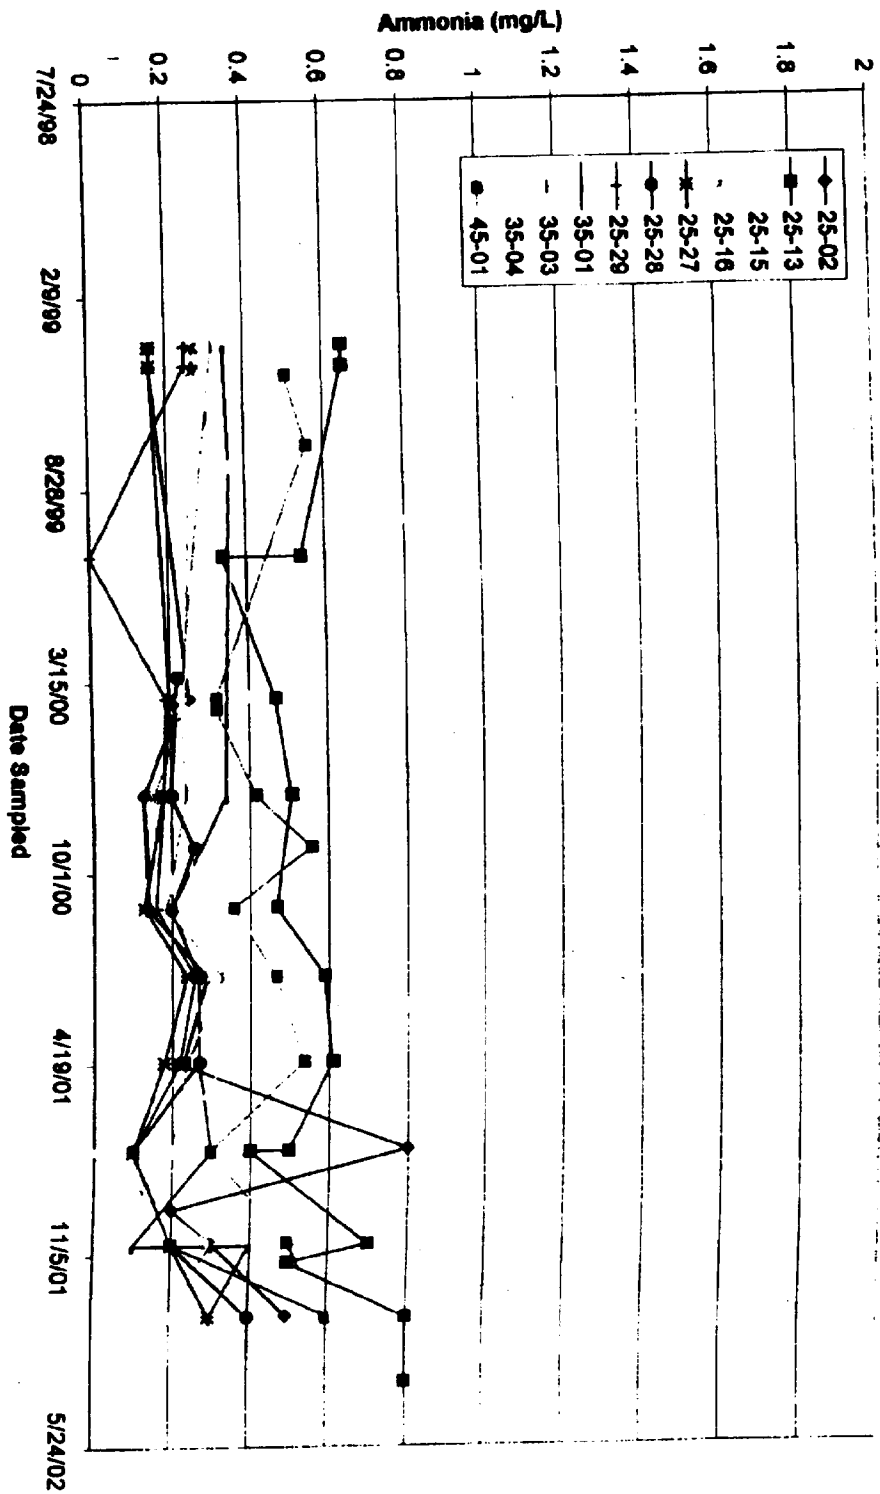
Figure 17. Ammonia Trends Remaining BWL Wells  
Through First Quarter 2002

Page 16, top paragraph. As just noted above, several BWL wells have shown increasing trends in the past 3 to 4 sampling events. These trends can be seen in Figure 17 as well.

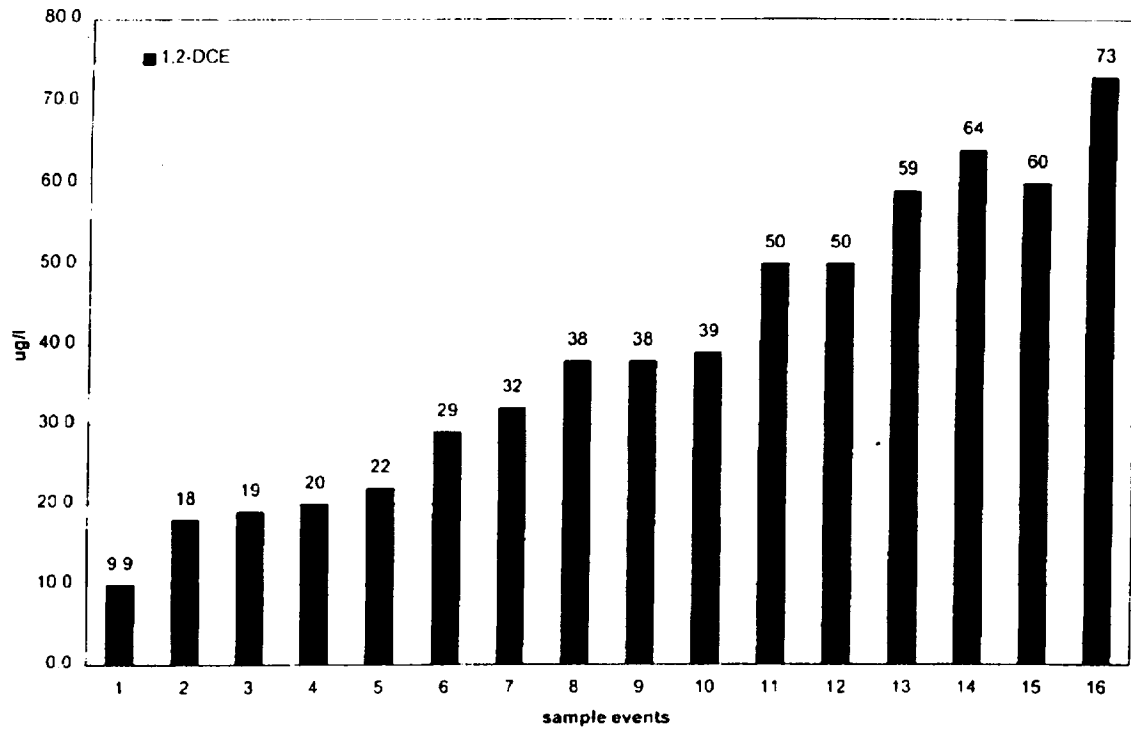
1,2-DCE in MW-37

There was no mention in this section that MW-37 exceeded cleanup concentrations (70 µg/l) this quarter with results of 73 µg/l. The focus of the discussion was primarily with off-site contamination to the north. As noted in past quarterly comment letters, MW-37 has had a
